10TH STREET SUBSTATION EXCAVATION OF THE
ACEQUIA MADRE (41 BX 8), SAN ANTONIO, BEXAR COUNTY, TEXAS

Center for Archaeological Research
The University of Texas at San Antonio®
Archaeological Survey Report, No. 153

The acequias or irrigation systems were an important factor in the early history of San Antonio. One of the earliest of these was the Acequia Madre (41 BX 8) or Mother Ditch. Recently, proposed construction by City Public Service at the 10th Street Substation was expected to encounter the course of the acequia, thus requiring archaeological investigation. Excavation of a section of the acequia with a backhoe and archival research revealed new information about the history of this ancient waterway.

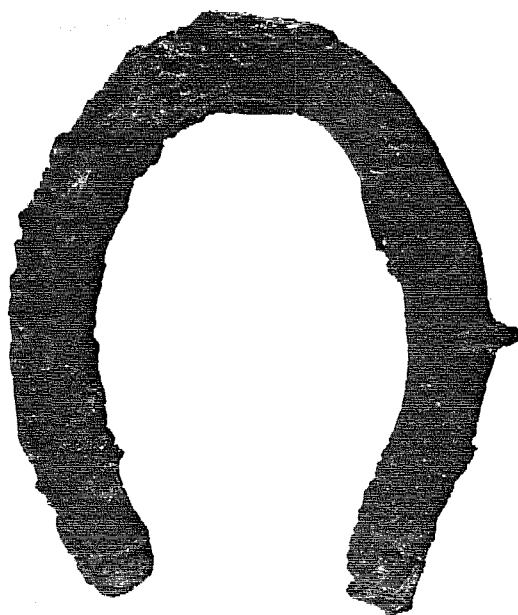
Figure 3. Selected Ceramic and Metal Artifacts from the Acequia Madre at the 10th Street Substation.

- a, decal-decorated porcelain plate;
- b,c, fragments of gold-decorated ironstone pitcher;
- d, luster decoration on porcelain;
- e, stoneware crock fragment;
- f, stoneware ink bottle fragment;
- g, oil can;
- h, horseshoe.

- 29 fragments of undecorated whiteware.
- 4 fragments of porcelain.
- 7 fragments of gold-decorated ironstone pitcher (Fig. 3,b,c).
- 1 fragment of a transfer print plate or saucer.
- 1 fragment of hand-painted porcelain.
- 1 fragment of a decal-decorated porcelain plate (Fig. 3,a).
- 1 fragment of luster decoration on porcelain (Fig. 3,d).
- 1 fragment of yellow ware with Rockingham glaze.
- 2 stoneware crock fragments, one a base fragment with the following:
" . . . comb/. . . ware Co./. . . comb" (McComb Stoneware Co.,
McComb Illinois; Fig. 3,e).
- 2 stoneware ink bottle fragments, one with "Vitreous Stone Bottles/J.
Bourne & Son/Patentees/Denby Pottery/near Derby/P & J Arnold/
London/England" (Fig. 3,f).
- 5 porcelain electrical insulators.
- 1 porcelain and brass electric lamp base for screw-in bulb.

- 1 top of fire hydrant.
- 1 oil can (Fig. 3,g).
- 3 spikes.
- 1 bolt.

- 5 pieces of wire.
- 1 brass gas connection.
- 1 horseshoe (Fig. 3,h).
- 1 iron pipe section, possibly holder for carbon rod.
- 5 pieces unidentified metal scrap.

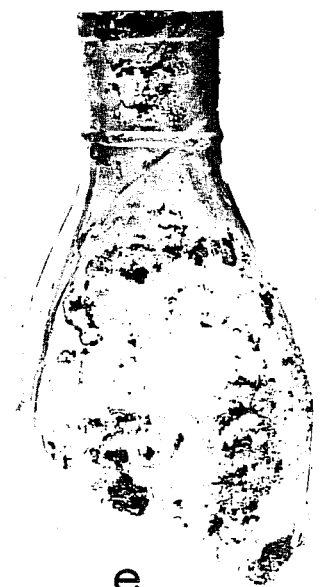
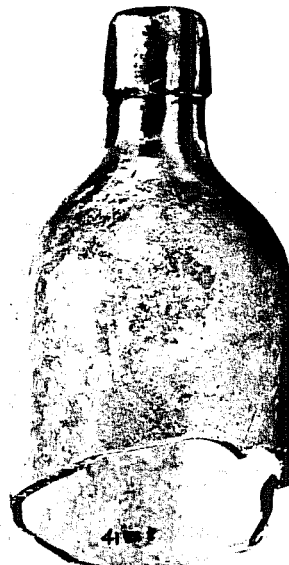
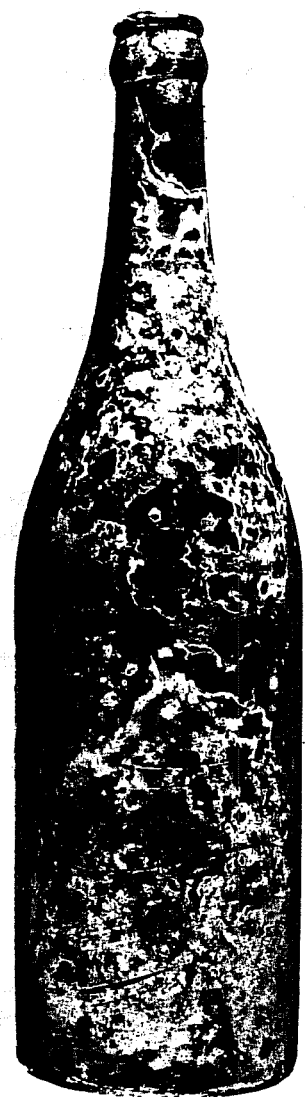
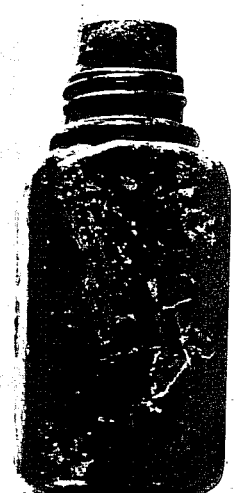
Figure 4. Selected Glass Artifacts from the Acequia Madre at the 10th Street Substation.

- a, goblet base;
- b, telephone pole insulator;
- c,d, molded bottles;
- e, clear bottle;
- f, short neck bottle with molded lip;
- g, condiment bottle;
- h, long neck bottle, produced in two-piece mold;
- i, long neck bottle, produced in turn mold;
- j, clear milk or cream bottle;
- k, brown square bottle with screw cap.

- 1 entire clear taper-sided condiment bottle 5-3/8 inches high
(Fig. 4,g).
- 1 entire extruding shoulder clear bottle with sides tapering to square
base 3-3/4 inches high (Fig. 4,e).

- 1 entire clear milk or cream bottle, square with truncated corners
6-3/4 inches high (probably post 1880s; Fig. 4,j).
- 1 brown-shouldered long neck bottle produced in two-piece mold, seam
extends only to base of lip, 11-1/2 inches high, bottom marked "C M
Co./F 28" (probably 1880-1900; Fig. 4,h).

- 1 entire brown-shouldered long neck bottle, machine made in turn mold
with crown cap, 11-1/2 inches high (probably 1892-1900; Fig. 4,i).
- 1 broken aqua-shouldered short neck bottle with molded lip, produced in
two-piece mold (probably 1880-1900; Fig. 4,f).

- 1 brown square bottle with screw cap, 4-1/2 inches high, marked
"P M/F S Co." on bottom (Fig. 4,k).
- 1 fragment round cobalt blue bottle.
- 1 fragment square aqua bottle produced in two-piece mold.

- 2 neck fragments of small molded bottles, 1 clear, 1 aqua (Fig. 4,c,d).
- 1 fragment ointment jar.
- 2 fragments lamp chimney.
- 2 fragments of pressed glass tumbler.

- 2 goblet base fragments, clear (Fig. 4,a).
- 1 fragment aqua telephone pole insulator (Fig. 4,b).
